## After the Flood

**Since people continue to build - and rebuild - their houses in flood prone areas, finding the materials that hold up best after flooding could save energy and money and keep tons of material out of landfills.**

BY [HESHMAT AGLAN](#) and [SHERRY LIVENGOOD](#)

January 01, 2003

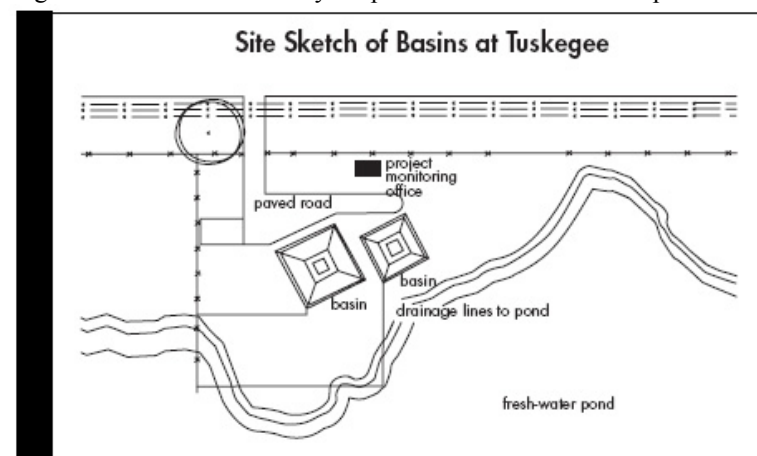
Figure 1. Two basins, one for a crawlspace module and the other for a slab-on-grade module, were flooded with pond water to test building envelopes exposed to flooding.

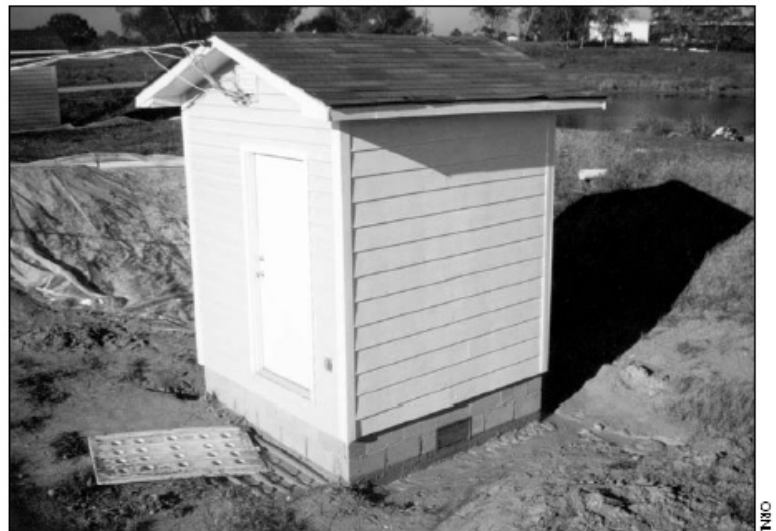
Because reproducing flood conditions in actual houses was not practical, we made small prototype test structures.

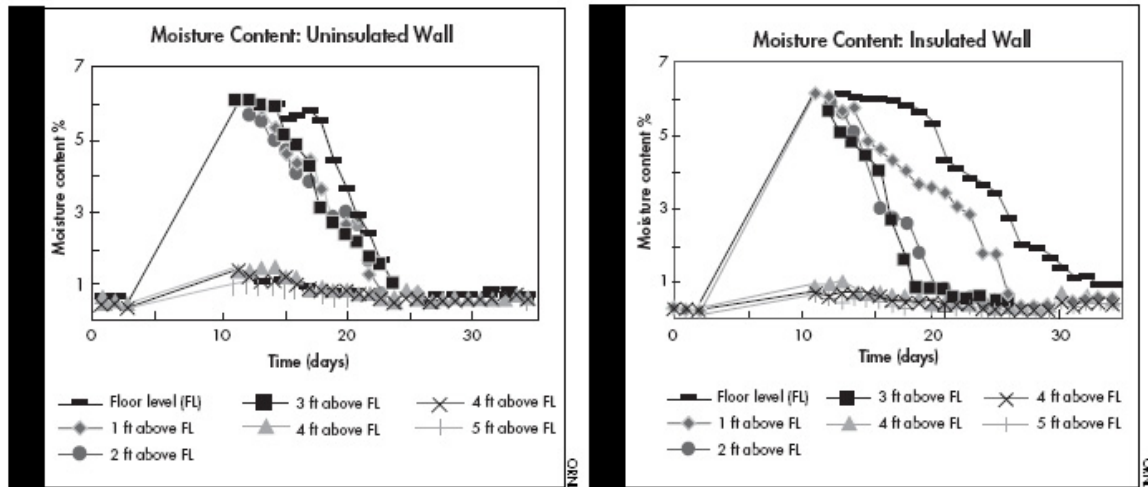
As anticipated, the paper-faced gypsum wallboard remained unserviceable where it was installed on the inside of fiberglass-insulated exterior walls. The batt insulation appeared to act like a sponge and held water. However, on interior partitions, where there was no insulation in the wall cavity, the gypsum wallboard was in good enough condition to be lightly sanded, resurfaced, painted, and returned to use (see Figures 4 and 5). Where there was no insulation in the wall cavity, the area drained and dried more rapidly. Subsequent mechanical properties testing of materials revealed that the gypsum board on the interior walls did not lose significant strength (see Table 2).

**Figure 4.** (left) This shows the moisture content versus time for the gypsum board on the uninsulated interior wall of a test module. The entire wall (top to bottom) dried within 25 days. **Figure 5.** (right) This shows the moisture content versus time for the gypsum board on the interior of an insulated outside wall. Notice how the floor level and 1 ft above floor level retains moisture for 5 to 10 days beyond the upper portion of the wall. This is due to moisture retained by the fiberglass insulation.
