## After the Flood

**Since people continue to build - and rebuild - their houses in flood prone areas, finding the materials that hold up best after flooding could save energy and money and keep tons of material out of landfills.**

BY [HESHMAT AGLAN](#) and [SHERRY LIVENGOOD](#)

January 01, 2003

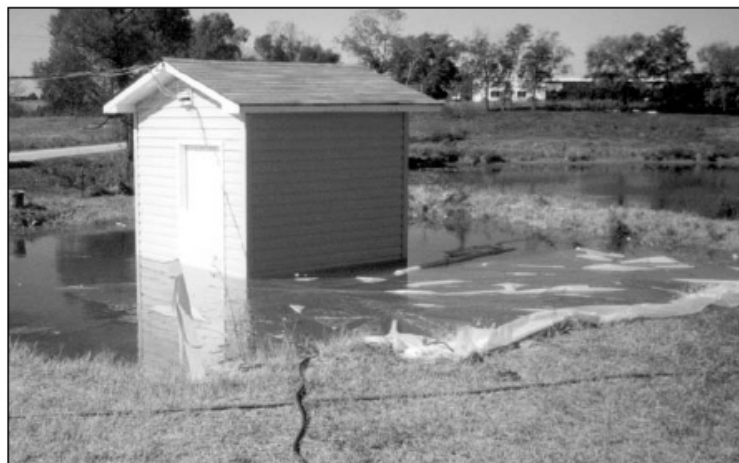
Because reproducing flood conditions in actual residential structures would be extremely expensive and impractical, we instead designed small prototypical test structures—8 ft x 8 ft modules placed in outdoor basins in Tuskegee, Alabama (see photo above and Figures 1 and 2). These test modules simulate the materials and systems used in full-sized residential structures as well as representative flooding and real world drying conditions, while minimizing the cost of materials and construction. We built one slab-on-grade test module and one module with a crawlspace for each series of tests. Two series of tests have been conducted, and a third is underway.

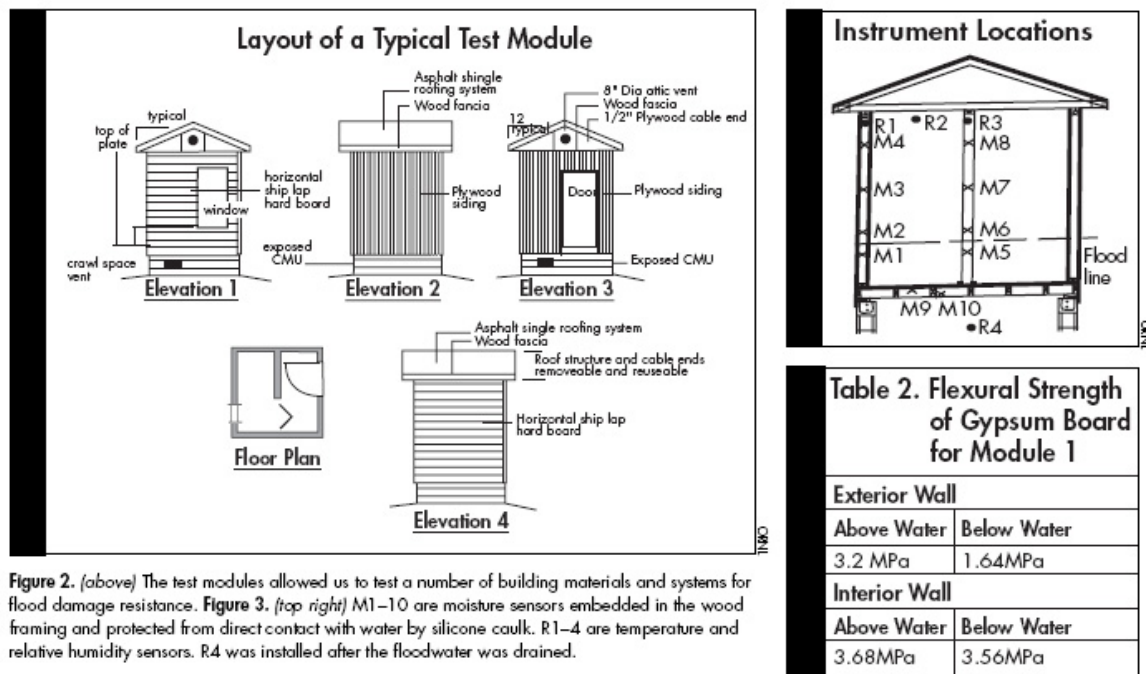
Inspection on day 8, when the modules were opened, the carpet removed, and the surfaces washed, revealed staining on the exterior walls below the water level, some warping of the vertical plywood siding, and vertical cracks in the exterior corner molding. The wooden door required about 10 lb of force to open (it stuck slightly), and it was discolored below water level.

Upon entering the test modules, we were welcomed by a strong musty smell. The carpeted areas were still fully saturated and slightly muddy. The hollow-core interior doors were stained and split at the bottom. There was a waterline on the gypsum board walls at approximately 2 ft above the floor level. The sealed concrete floor did not appear damaged. The paper drywall tape was peeling off the wall at joints and corners below water level. The paint on the walls was blistering below water level. The latex semigloss enamel appeared to fare better than the flat latex. The ceramic tiles on the floor and walls were in good condition, though the grout had been eroded on the flooring and was discolored throughout.

As anticipated, the paper-faced gypsum wallboard remained unserviceable where it was installed on the inside of fiberglass-insulated exterior walls. The batt insulation appeared to act like a sponge and held water. However, on interior partitions, where there was no insulation in the wall cavity, the gypsum wallboard was in good enough condition to be lightly sanded, resurfaced, painted, and returned to use (see Figures 4 and 5). Where there was no insulation in the wall cavity, the area drained and dried more rapidly. Subsequent mechanical properties testing of materials revealed that the gypsum board on the interior walls did not lose significant strength (see Table 2).
